Intel[®] Mobile Celeron[™] Processor at 466 MHz, 433 MHz, 400 MHz, 366 MHz, 333 MHz, 300 MHz, and 266 MHz Specification Update

Release Date: August 2000

Order Number: 244444-017

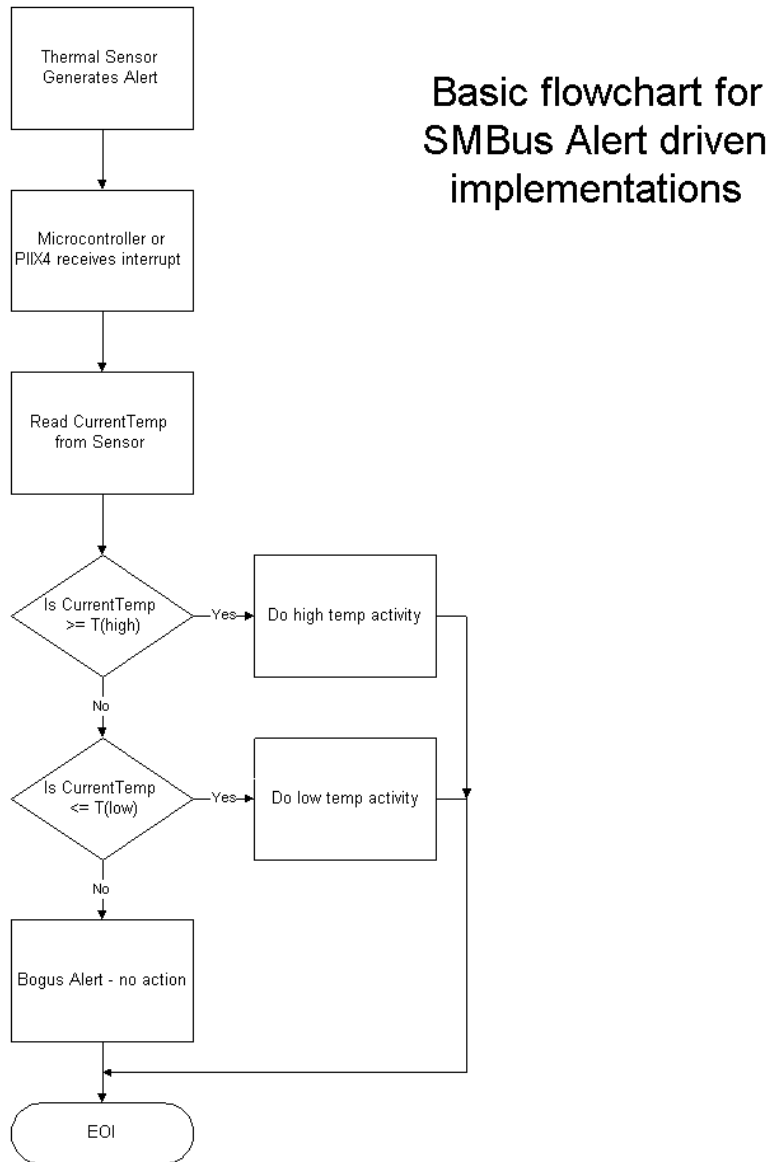
Figure 2. Workaround Flowchart: SMBALERT#-Driven System

Problem: The Intel Celeron Processor Mobile Module has a thermal sensor that monitors the processor core's temperature. Please note that desktop systems could have a similar thermal device. The thermal sensor asserts SMBALERT# if the processor temperature exceeds the temperature limits set in the Alarm Threshold Registers (T_{HIGH}, T_{LOW}). It also sets the corresponding Status Register bits to identify the cause of the interrupt. Figure 1 gives one example of the how the SMBALERT# signal could be used in a system.

1. Before servicing an interrupt from the thermal sensor, read and compare the processor thermal reading with the threshold limits (T_{HIGH} or T_{LOW}). Figures 2 and 3 provide basic flowcharts for the implementation of this workaround in an interrupt driven system.
2. If the firmware implemented polls the Status Register only, then before taking any action, re-read the temperature register and do a comparison with the alarm threshold limits (T_{HIGH} or T_{LOW}) to determine if the value is actually still within the temperature window.
3. Use a temperature polling scheme to monitor the processor temperature.

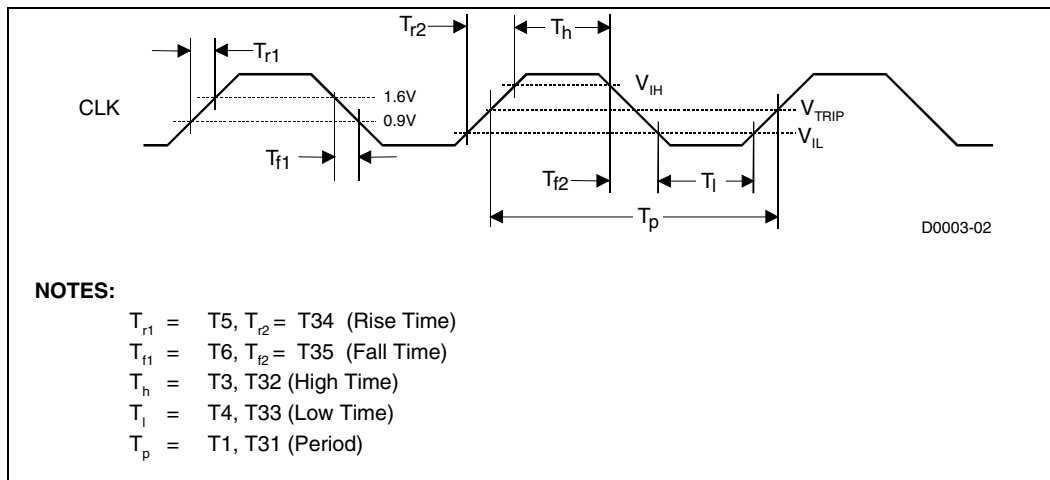
Figure 3.3 Generic Clock Waveform

Figure 3.3 in the *Intel® Mobile Celeron™ Processor in μ PGA1 and BGA1 Packages at 366 MHz, 333 MHz, 300 MHz, and 266 MHz* datasheet (Order Number 245112-003) has been updated. The following figure is to replace the one in the above document.
